# Manhole Inspection Summary

Manhole # S37A\_\_008MH

**Inspection** ☐ Is Incomplete Rating: **3) Fair**

Insp Date: **8/25/08 11:11 AM**

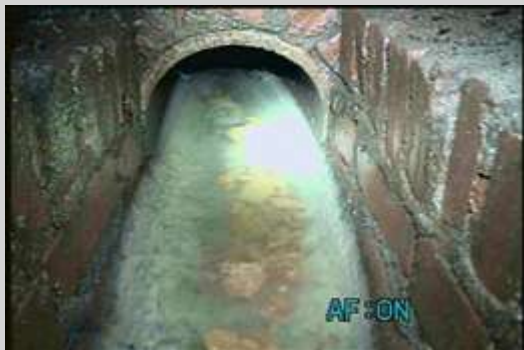
12 O'Clock Outflow

8 in. Circular Gravity Sewer  
Pipe Out @ 12 O'Clock

Pipe Material: **Clay** ☐ Pipe Lined

Invert Depth: **12.20** (ft.) Flow Characteristics: **Fast**

Deposits: ☒ None ☐ Mud ☐ Sludge ☐ Debris ☐ Grease

Infiltration: **None** Pipe Seal Cond: **Unknown**

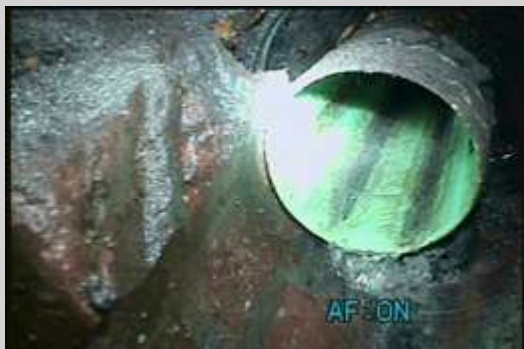
4 O'Clock Inflow

8 in. Circular Gravity Sewer  
Pipe In @ 4 O'Clock

Pipe Material: **PVC** ☐ Pipe Lined

Invert Depth: **12.00** (ft.) Flow Characteristics: **Slow**

Deposits: ☒ None ☐ Mud ☐ Sludge ☐ Debris ☐ Grease

Infiltration: **None** Pipe Seal Cond: **Unknown**

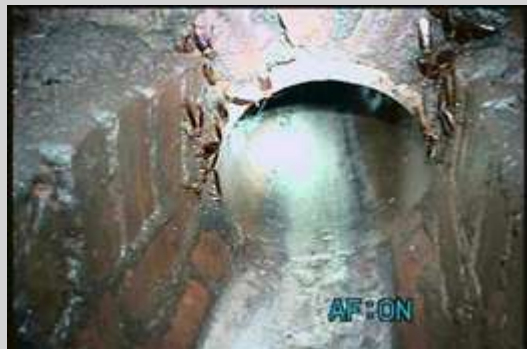
6 O'Clock Inflow

8 in. Circular Gravity Sewer  
Pipe In @ 6 O'Clock

Pipe Material: **Clay** ☐ Pipe Lined

Infiltration: **None** Pipe Seal Cond: **Unknown**
